SRFB Grant Regional Application Materials

Submission Date	2018-03-30 13:19:08
	Mill Creek Fish Passage Project
Sponsor Organization	Chelan County Natural Resource Department
Sponsor Contact Person	Mike Kane
Sponsor Address	411 Washington St
City	Wenatchee
State	WA
Zip Code	98801
Phone Number	509-885-2126
E-Mail Address	kanenaturalresources@gmail.com
PRISM#	181824
Habitat Work Schedule #	181824
Anticipated Request- SRFB	131476
Anticipated Request- Tributary Committee	0
Total Anticipated Request (SRFB and Trib)	131476
Anticipated Other Funding	494599
Anticipated TOTAL Budget	626075
% of budget request from SRFB	21
In one or two sentences, what do you propose to do?	The proposal will be for final design, permitting and construction of a fish passage barrier replacement on Mill Creek, a tributary to Peshasting Creek.
What subbasin is the project in?	Wenatchee
What project category is your project?	Restoration
Has this project previously been submitted for funding through SRFB?	Yes

Mill Creek Fish Passage Project

Project Number	18-1824
Project Name Mill Creek Fish Passage Project	
Sponsor Chelan County Natural Resource Department

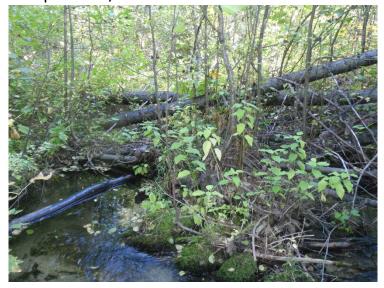
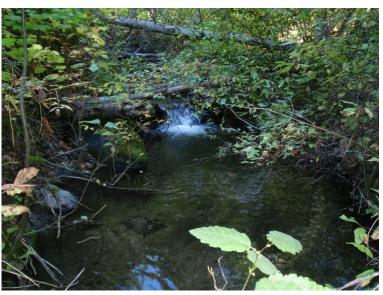
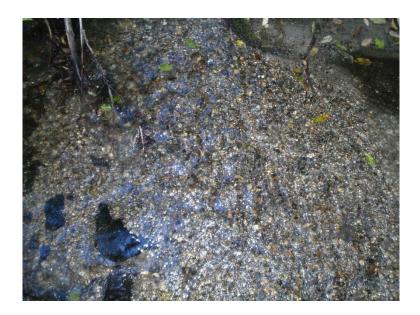
Figure 3. Mill Creek photos from informal habitat survey, CCNRD September/October 2010

Young riparian community and LWD on Mill Creek (about RM 1.2) in area where Rat Creek Fire and/or past logging reduced mature conifer/deciduous cover.

Pool habitat at aout RM 1.0 on Mill Creek

Small Gravels in Mill Creek near RM 1.0

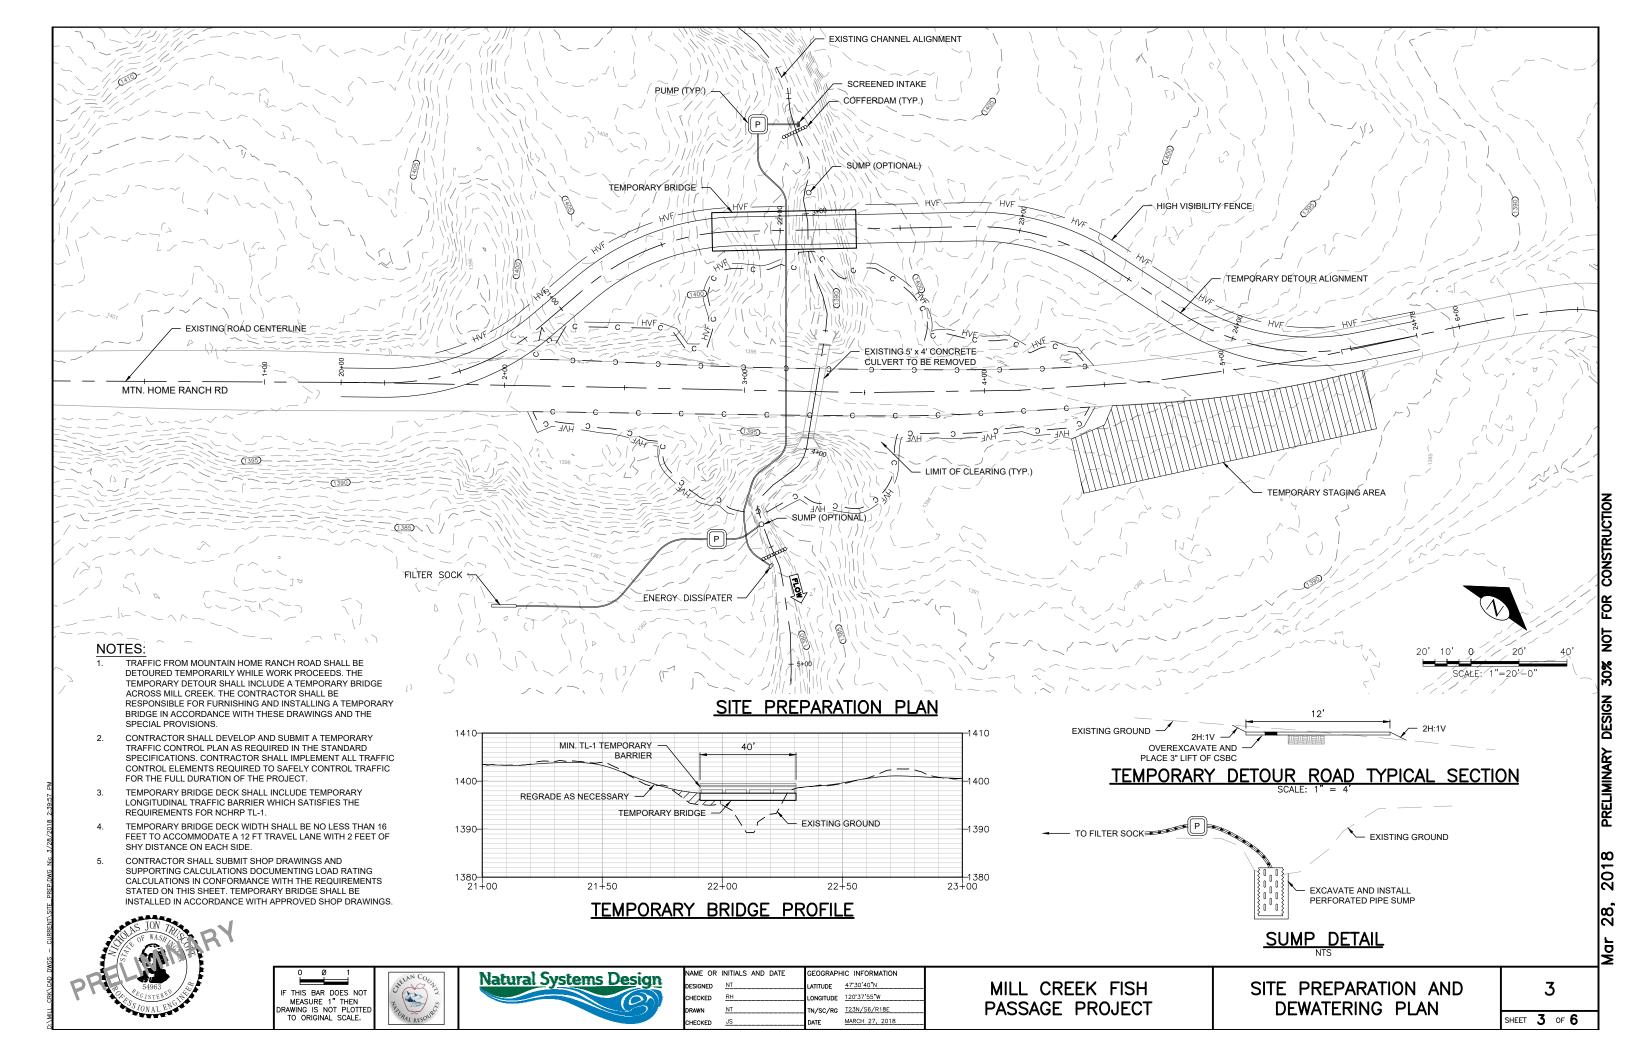
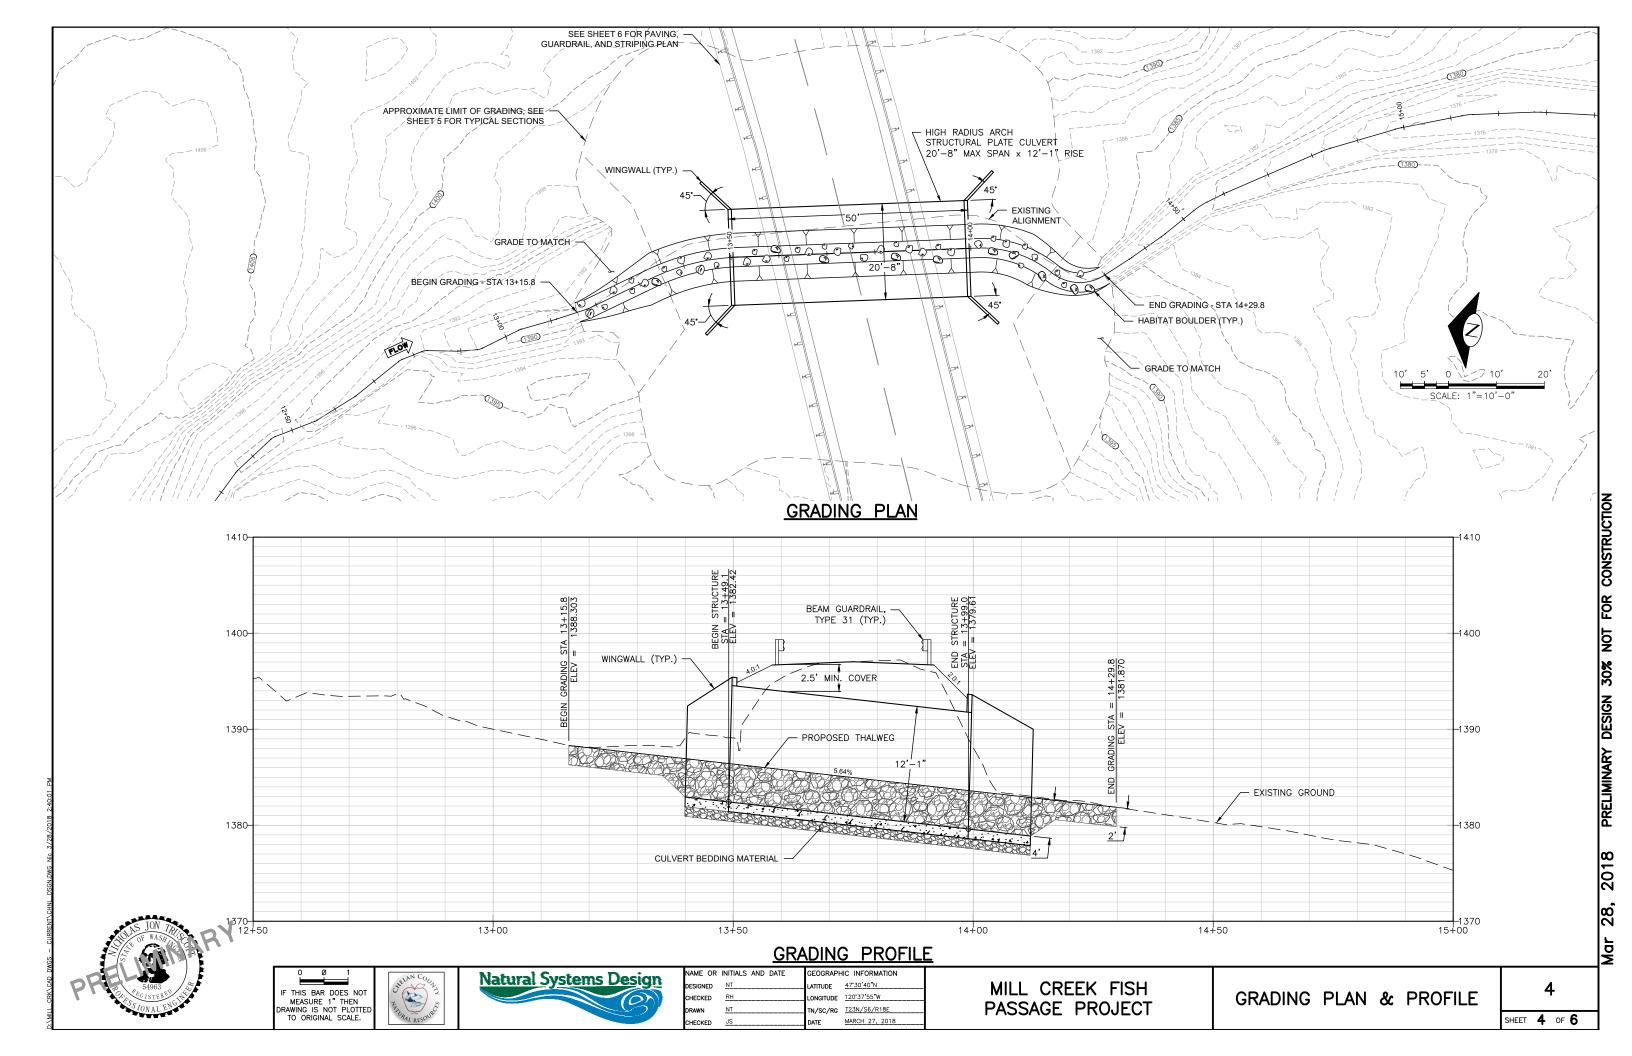
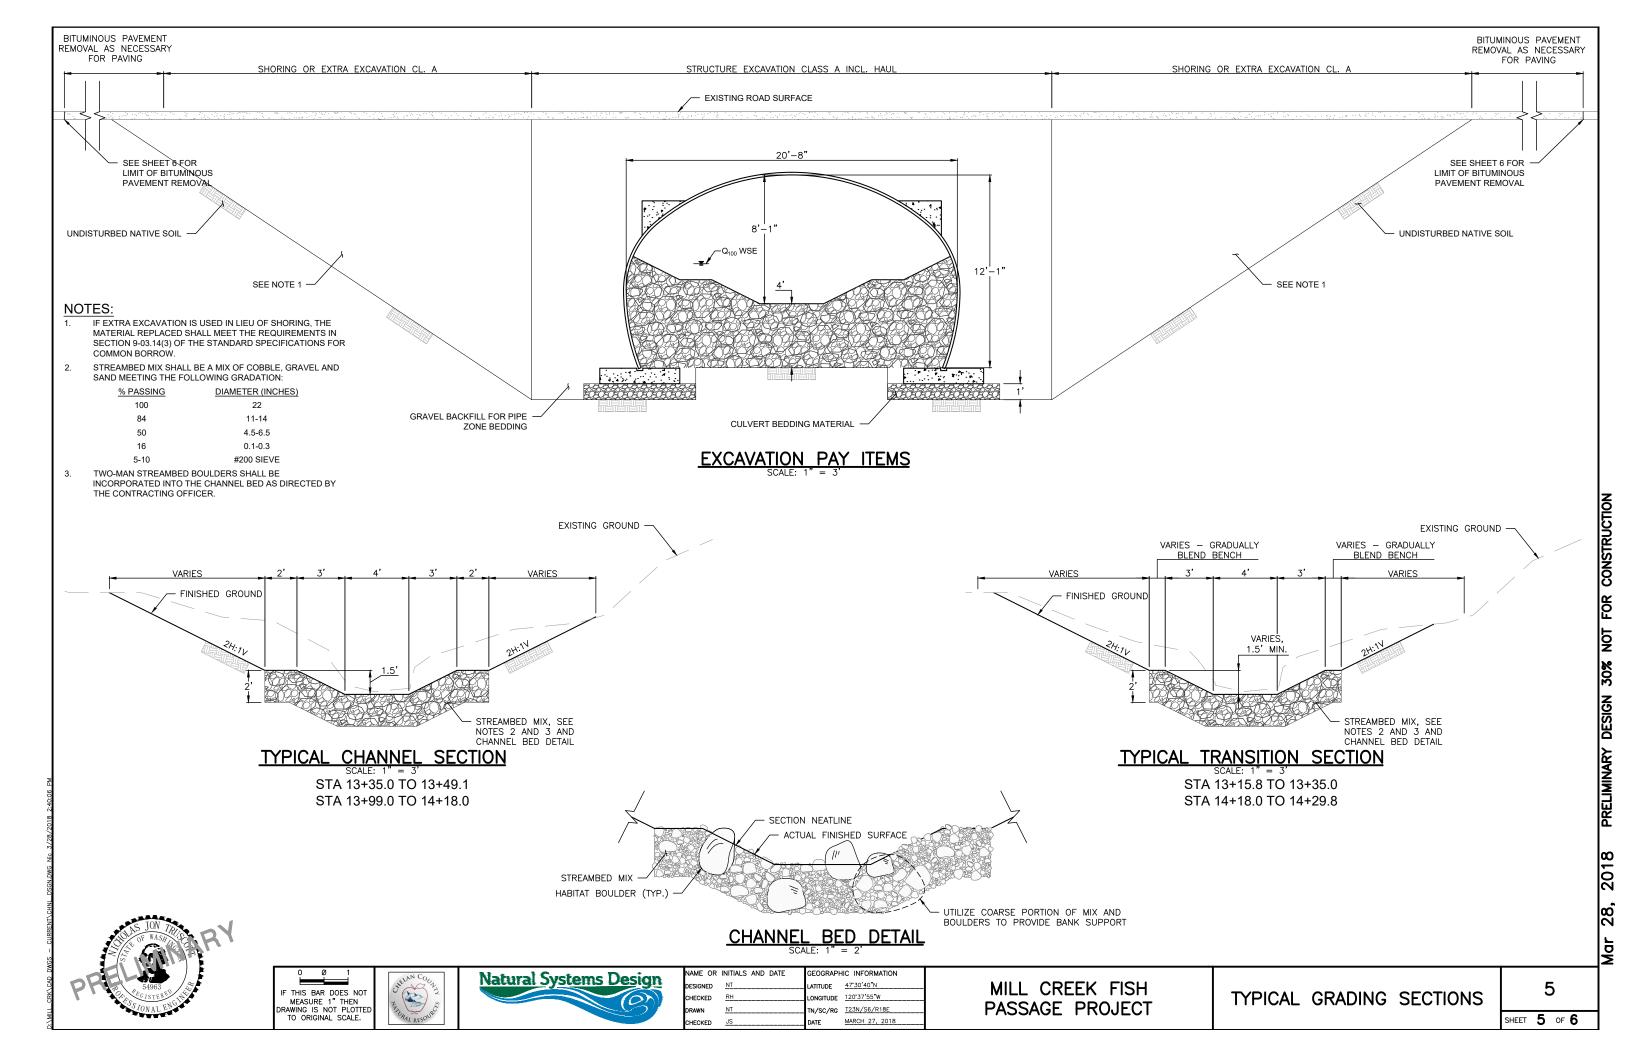
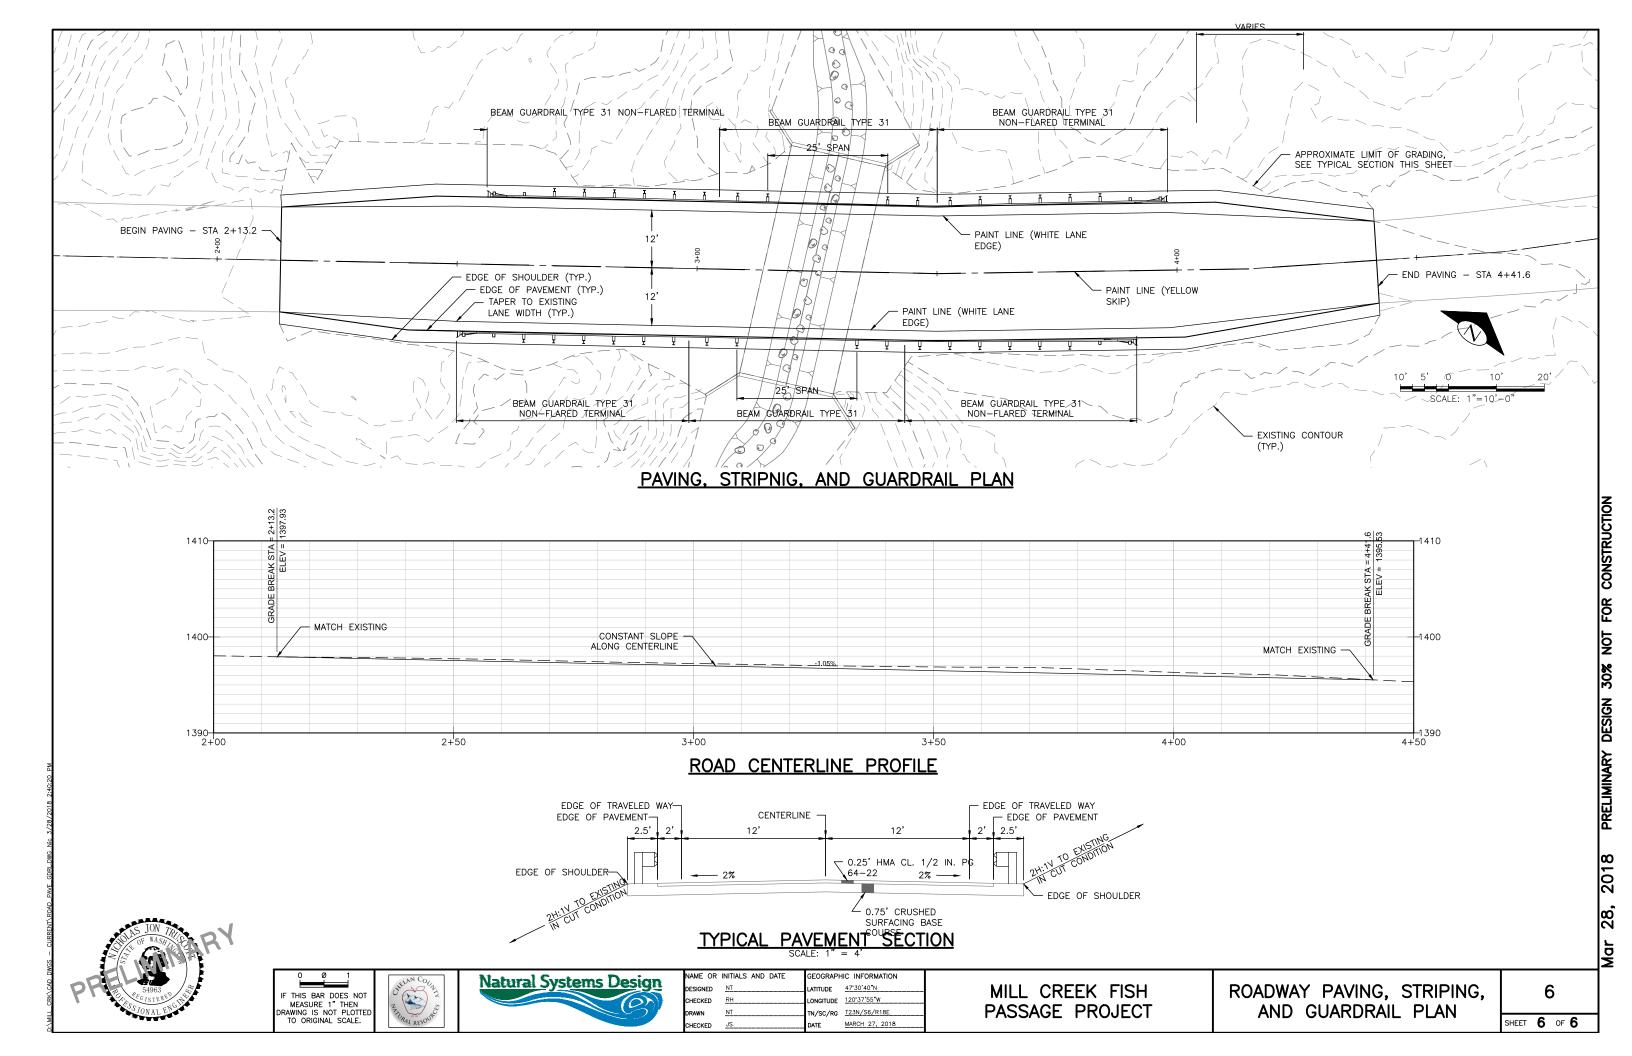
DRAWING LIST						
SHEET N	SHEET NO. SHEET TITLE					
1		COVER SHEET				
2		NOTES & SUMMARY OF QUANTITIES				
3		SITE PREPARATION AND DEWATERING PLAN				
4		GRADING PLAN & PROFILE				
5		TYPICAL GRADING SECTIONS				
6		ROADWAY PAVING, STRIPING, AND GUARDRAIL PLAN

"Figure 5" of this document is the complete set of 30% design plans. 60% preliminary designs have not been completed. The design team has included total project cost and anticipated match from FBRB for this project, but does not have a completed basis of design report at this time and does not have current funding to complete prior to the final PRISM submittal. The sponsor has reduced the ask from SRFB to \$131,476 (21%).

The potential for debris flows to scour structure foundations or plug the replacement structure led to the decision to increase structure span (for conveyance) and footing depth (for scour protection) beyond the minimum required for stream simulation design.
