WDFW Fish Passage and Diversion Screening Inventory Database

Site Description Report

Other Feature Assessment Report

Site ID:	602260		
Latitude:	47.51181	Stream:	Mill Cr
Longitude:	-120.63328	Trib To:	Peshastin Cr
		WRIA:	45
		Fish Use Potential:	Yes

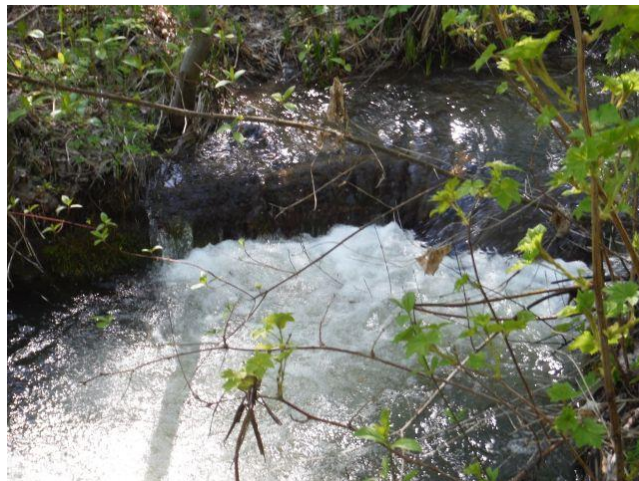
6 steambed controls D/S of site #950183.

Barrier:	Yes
Reason:	WS Drop
Passability (%):	33
Recheck:

Largest WSD is 0.54m.
