**ASOTIN CREEK**  
**INTENSIVELY MONITORED WATERSHED:**  
**RESTORATION PLAN FOR CHARLEY CREEK,**  
**NORTH FORK ASOTIN, & SOUTH FORK**  
**ASOTIN CREEKS**

**APRIL 25, 2012**

**Snake River Salmon Recovery Board**

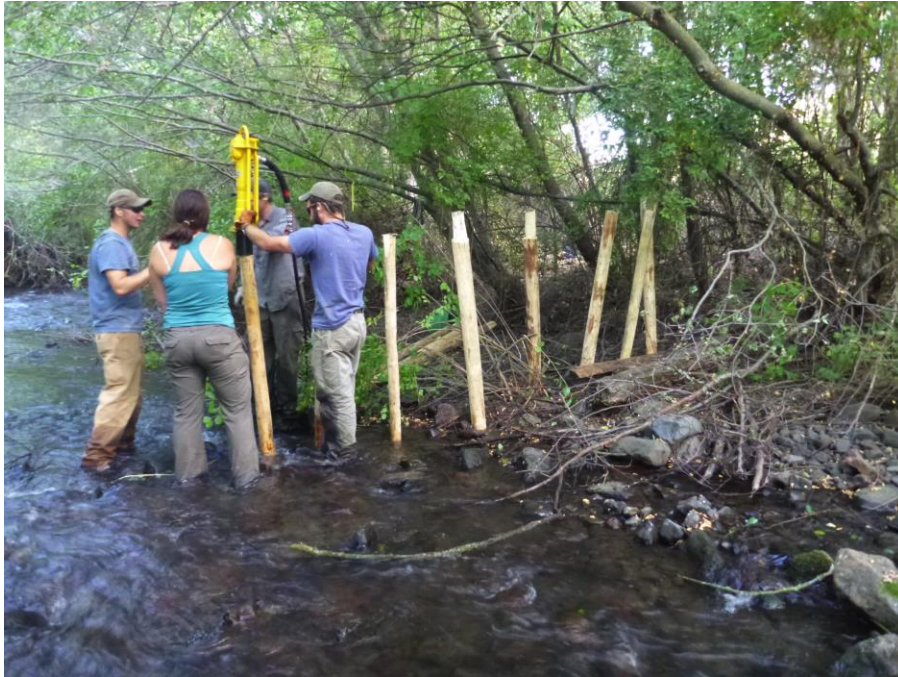
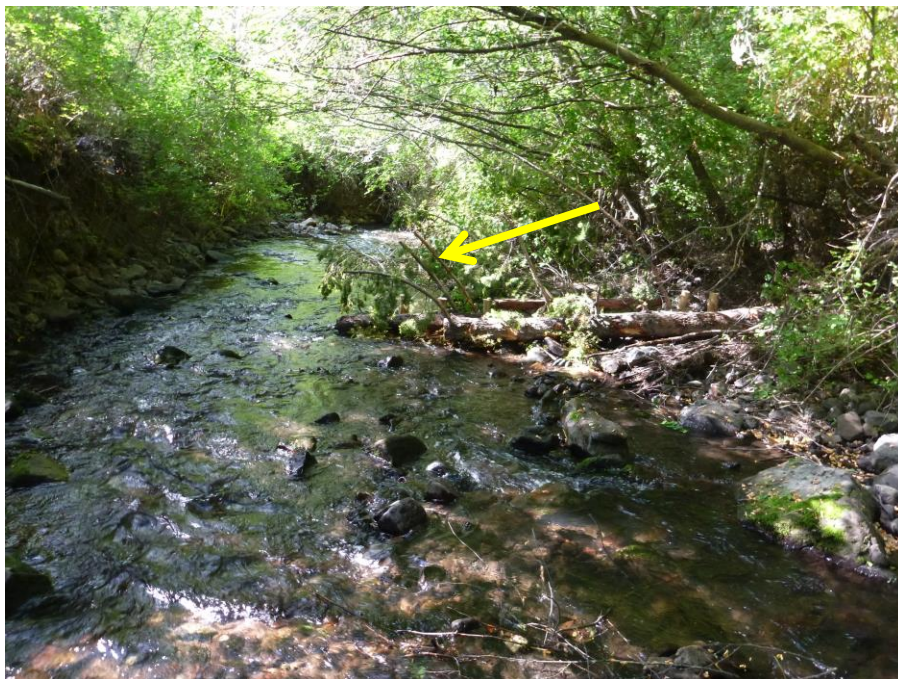
**Figure 16. Example of a) the installation of posts and trial structure using a hydraulic post driver and b) the completed structure with LWD added in South Fork Creek trial site TX-2. Yellow arrow indicates location of completed structure. Posts cut to average high flow level after installation.**

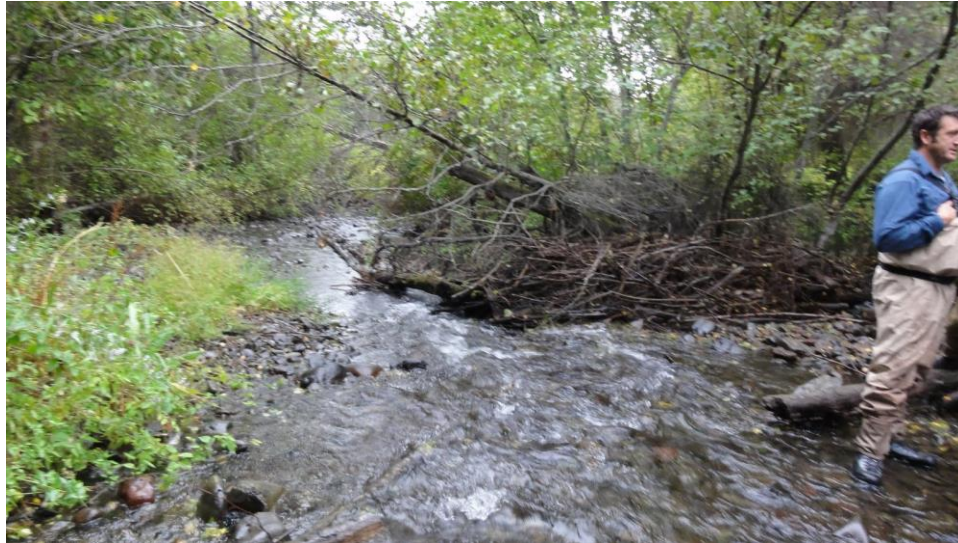
**Figure 24. Example of a width constriction on North Fork Creek. Note the debris pile on river-right that is forcing the flow towards the left bank, creating a pool downstream, and the vegetated sediment bar upstream of the width constriction.**

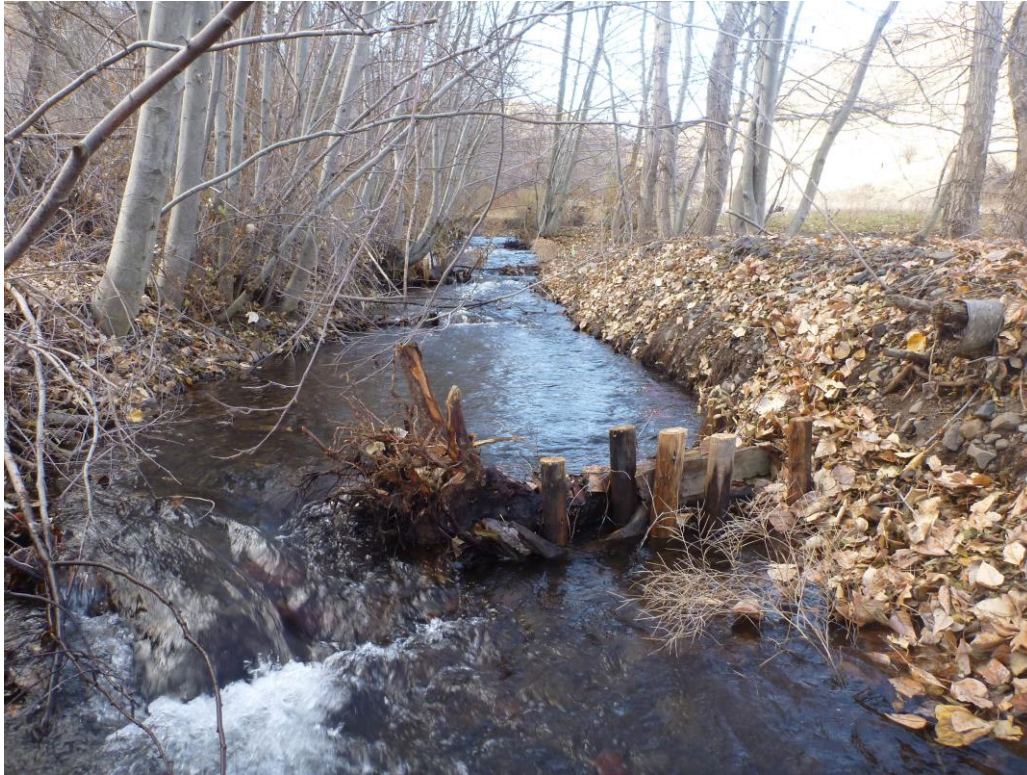
**Figure 28.** Example of a trial restoration structure on Charley Creek (CC-TX1). A root wad was added to this DWS to aid in forcing a width constriction to this straight and homogenous portion of channel (flow is towards the reader, structure is placed on river left). Note the steep banks and coarse material. CC-TX2 and CC-TX3 can be seen 25 m and 50 m upstream from CC-TX1.

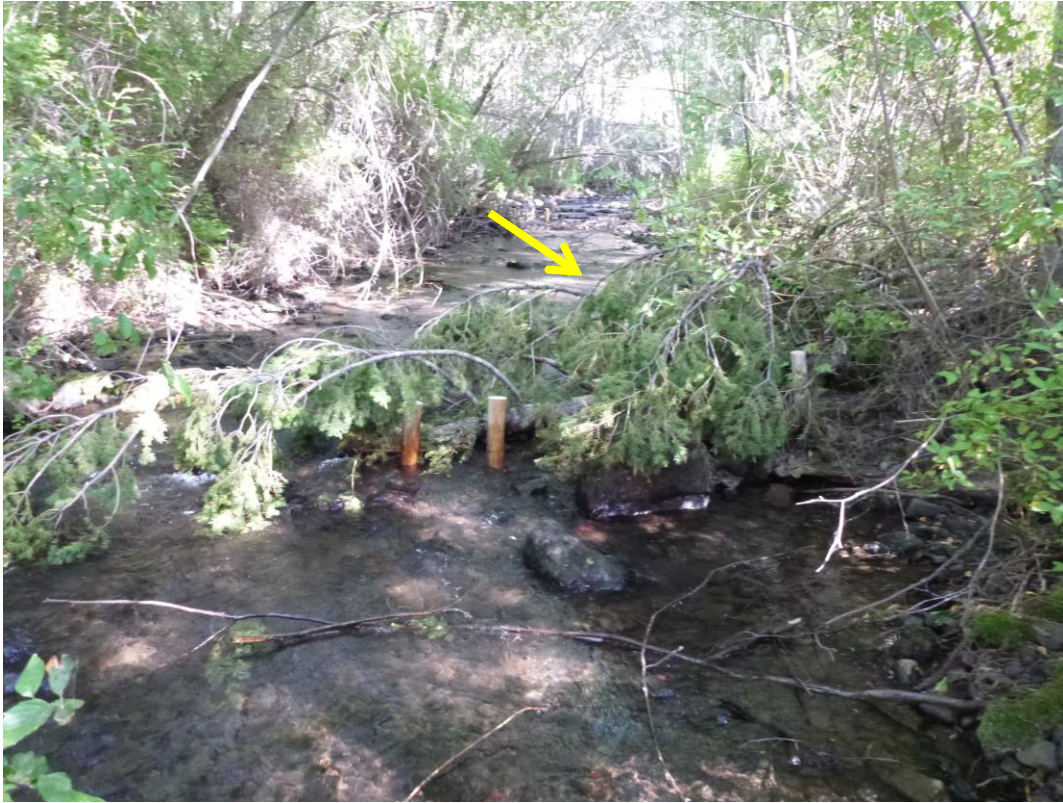
**Figure 30.** Example of a trial DWS on South Fork Creek (SF-TX3). A green piece of LWD with branches was added to this structure to increase the likelihood it will trap other debris washed downstream. Flow is towards the reader and structure is placed on river left. Note the extensive riparian vegetation, wide and shallow channel, and large substrate of cobble and boulders. Yellow arrow points to SF-TX4 50 m upstream on river right from SF-TX3.

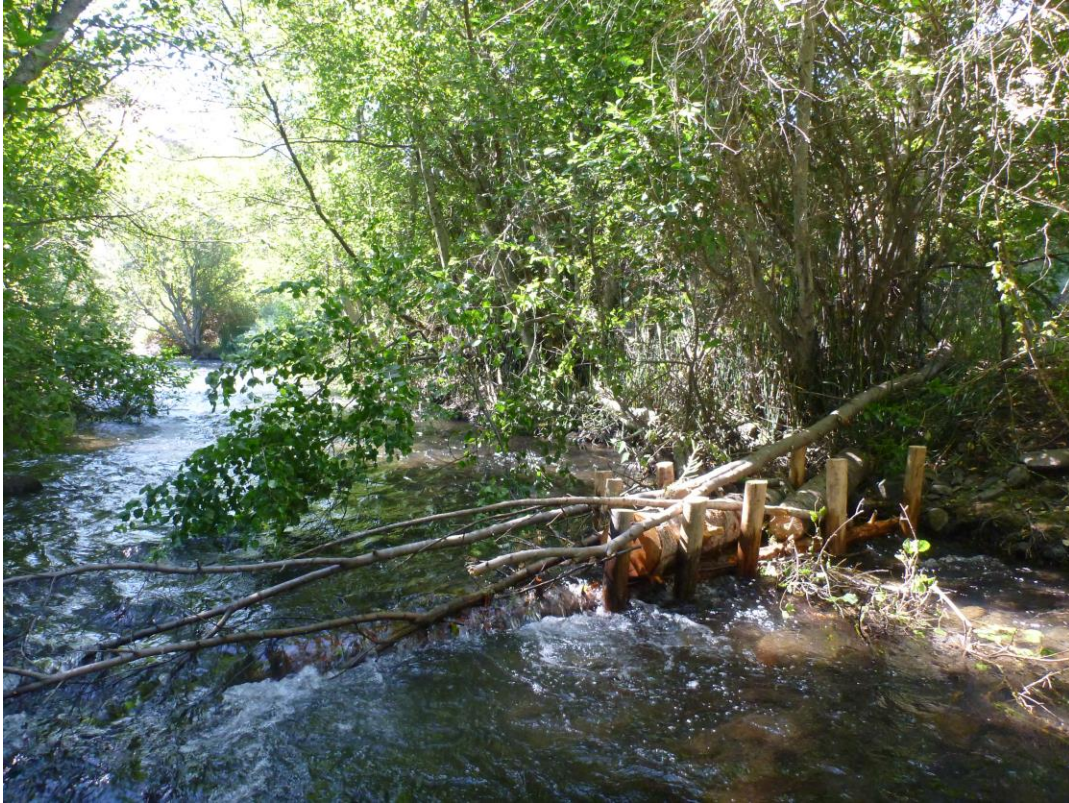
**Figure 33. Example of a trial DWS on North Fork Creek (NF-TX1). This is an example of a more complex structure as the posts were driven in an off-set pattern. LWD was then added diagonally between the posts to lock the pieces together. Flow is towards the reader and structure is placed on river left. Note the extensive riparian vegetation, wide and shallow channel, and LWD extended beyond the posts to constrict flow.**

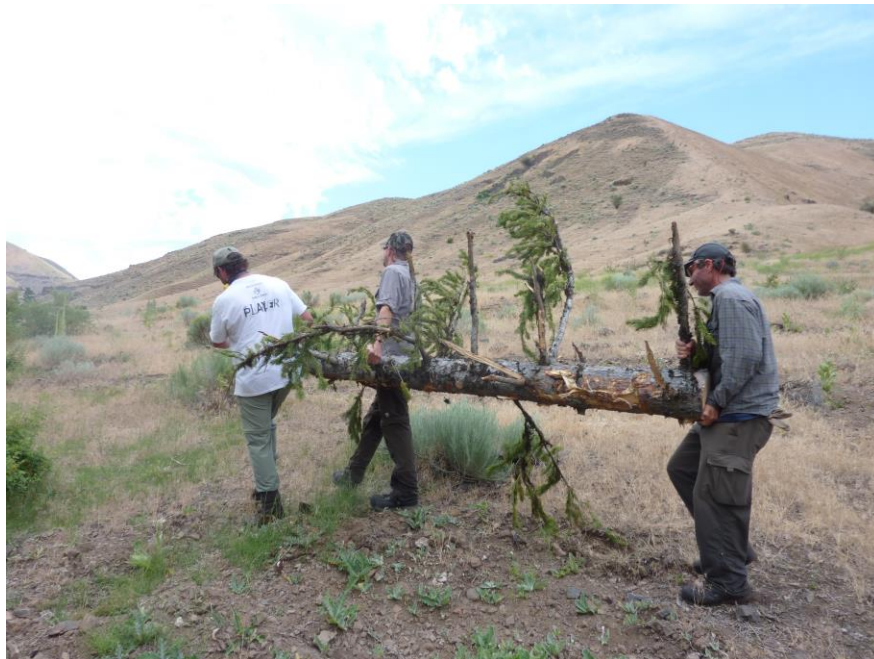
**Figure 41. Example of the transportation mode and size of LWD that will be used to build Dynamic Woody Structures during the Asotin Creek IMW restoration.**

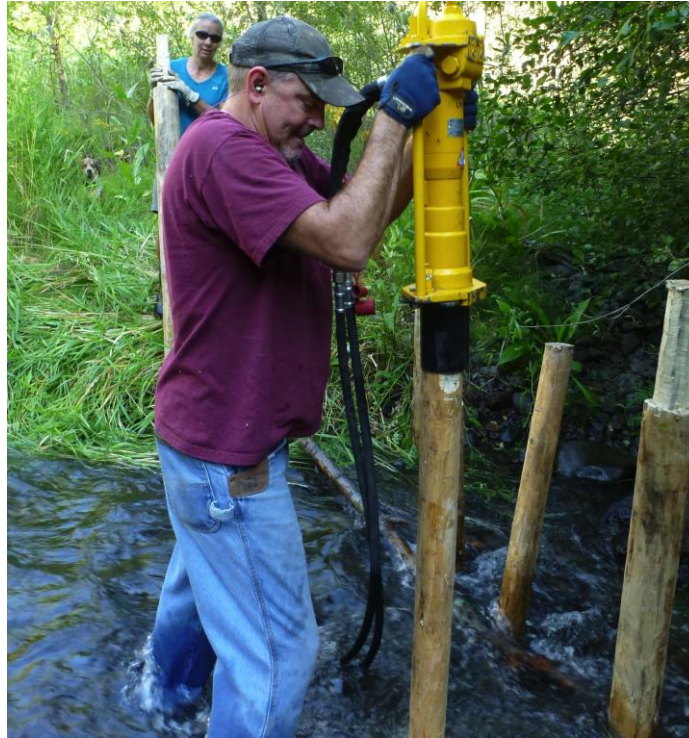
**Figure 42. Example of the hydraulic post driver that will be used to install DWS in Asotin Creek.**

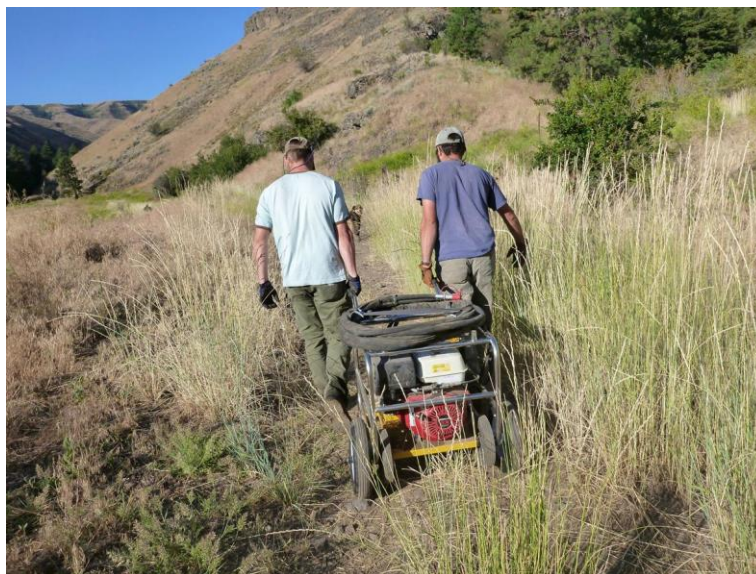
**Figure 43. Example of the hydraulic power unit used to power the post driver for installing DWS in the Asotin Creek Watershed.**
